東京市の復興と歩んだ建物

Takya City Reconstruction and the Birth of the Hongo Building

文 | 栢木まどか 東京理科大学工学部建築学科准教授

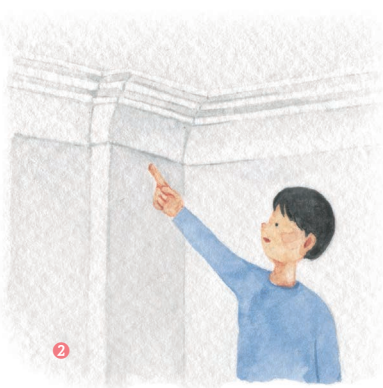
くことが出来ました。ほかに1階に接続室、2階に医務室と宿直室、各階に事務室が計画されていました。躯体は鉄筋コンクリート造で、部屋の間仕切りは木造です。断面図を見ると、屋上は、東から西に向けて下がる水勾配の傾斜がかなり大きくつけられています。これにより3階の梁も斜めになっています。いまは一部のみ残る天井のモールディング②は、すべての部屋で同様に仕上げられています。建物の裏側には煙突が3本あり③、これは1〜3階の各室に設けられたストーブのためのものでした。現在も、煙突の外観は残されています。
